Experimental Strengthening of Damaged and Un-Damaged RC Frames with Ultra-FRC Composite Layers

Sharbatdar, M.K.^{1*} and Mohazen, N.A.²

ABSTRACT: FRC concretes with high strength are practical material for strengthening existing particularly damaged concrete structures and able to dissipate seismic energy. The main purpose of this paper was to using high strength-FRC concrete for strengthening the damaged and undamaged frames. The five experimental specimens were loaded laterally and vertical gravity loads, simultaneously. The first specimen was a reference without strengthening, but the second same specimen was strengthened. The other three specimens were initially were loaded up to 55, 75, and 100% of the maximum capacity of the reference specimen and prepared as damaged specimens. The damaged specimens were laterally and vertically loaded. The test results showed that ductility of the undamaged strengthened frame was 2.2 times that of the reference specimen, while these amounts for three strengthened specimens (55, 75, and 100%) were up to 110, 60, 15 increase compared to the reference. The maximum lateral capacity of second undamaged, third fourth, and fifth damaged specimens

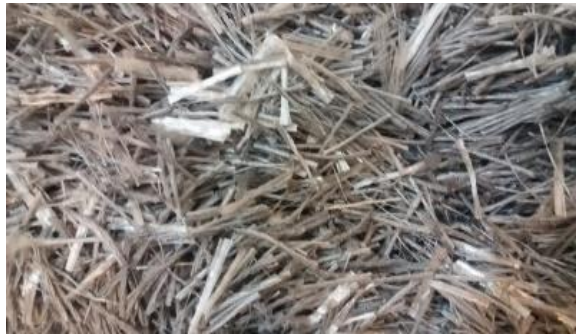
Fig. 1. PPS fibres

The sand (smaller than 4.75 mm) and gravel (4.75 to 12.5 mm) were used as aggregates. The used cement was type 2. PPS fibers were mixed with mortar for strengthening of the

frames. The properties and shape of these fibers was shown in Table 1 and Figure 1.

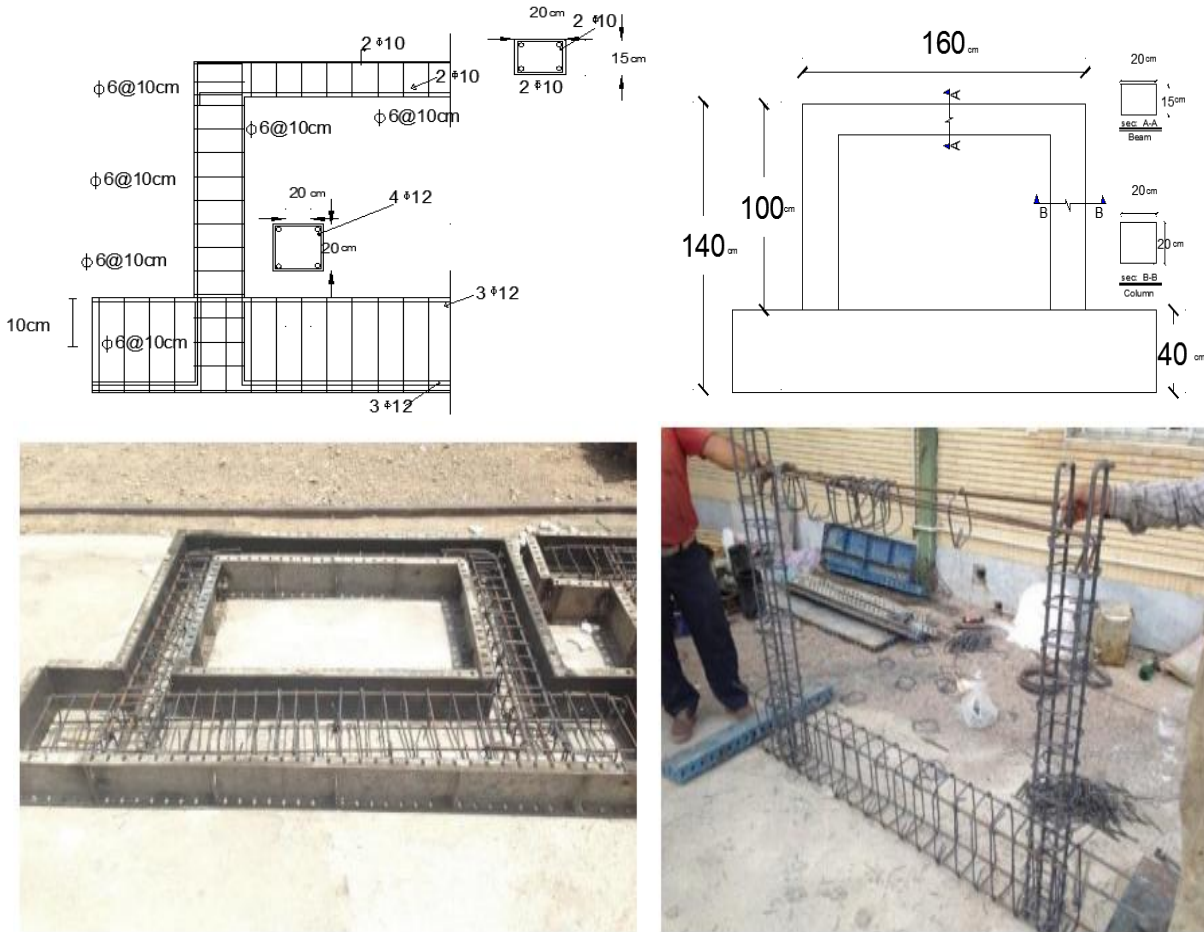
Fig. 2. Geometry and bar arrangement of specimens

The frame reinforcement details was shown in Figure 2. The beam and columns were reinforced with four 10 and 12 mm diameter bars as longitudinal and 6 mm diameter were used as stirrup for both beam and columns. The total lengths of the beam and column were 1.6 and 1 meter.

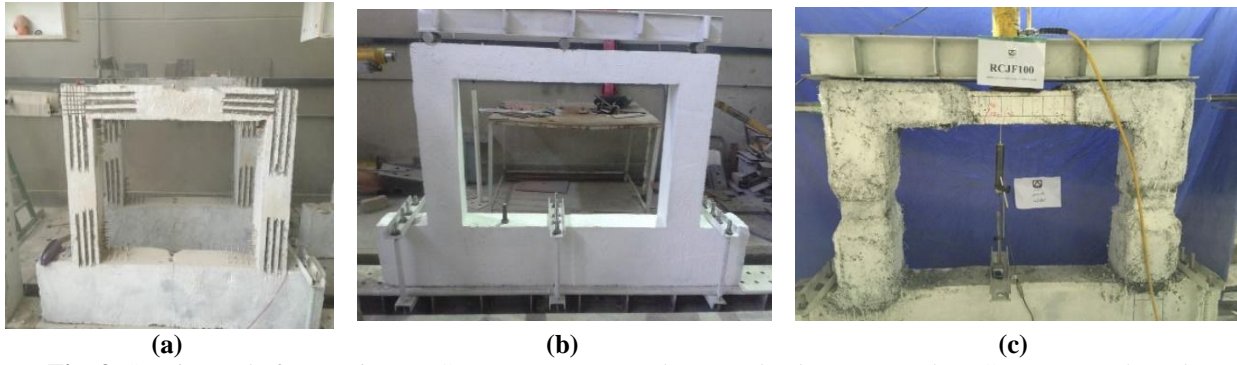
Fig. 3. Specimens before testing: a) Grooves on concrete beam and column cover; b) RCF; c) strengthened

To prevent probable de-bonding between the HPFRCC layer and hardened concrete, the grooves parallel the beam and column axial direction were considered on members covers. The general view of undamaged reference and strengthened undamaged and damaged frames with initial grooves before testing are shown in Figure 3.

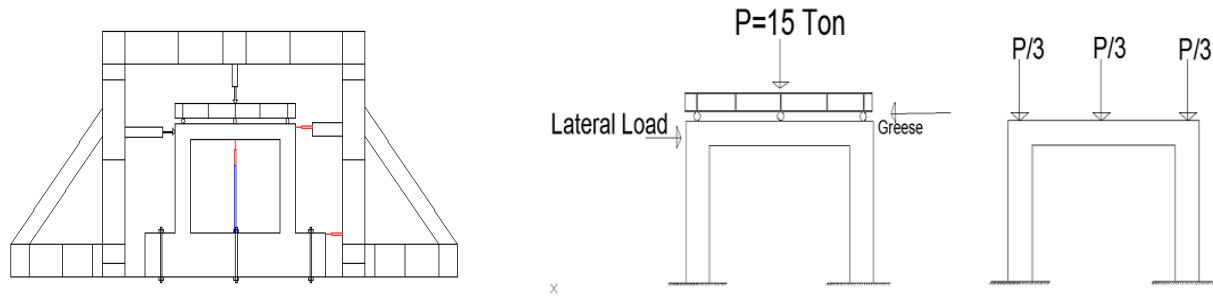
Fig. 4. Loading set-up

The vertical displacement of beam and lateral displacement of the frame of all specimens was measured via three LVDT,

and also the vertical and lateral load were measure by 300 kN load cells. Apart from bearing increasing lateral force by frame, a constant vertical loads was applied that was equivalent to around 10% nominal capacity (excluding rebar's strength) around 15 tons, shown in Figure 4. The loading system is displacement control and it was continued up to the collapse stage.

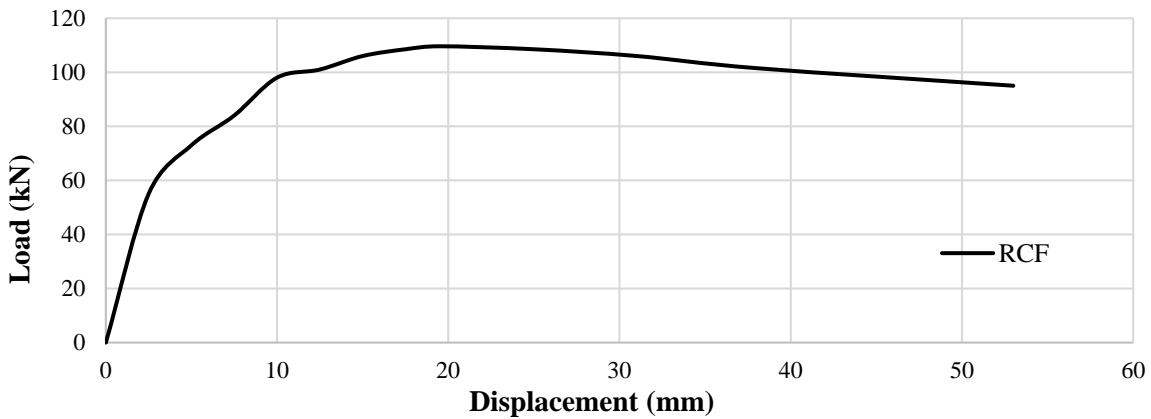
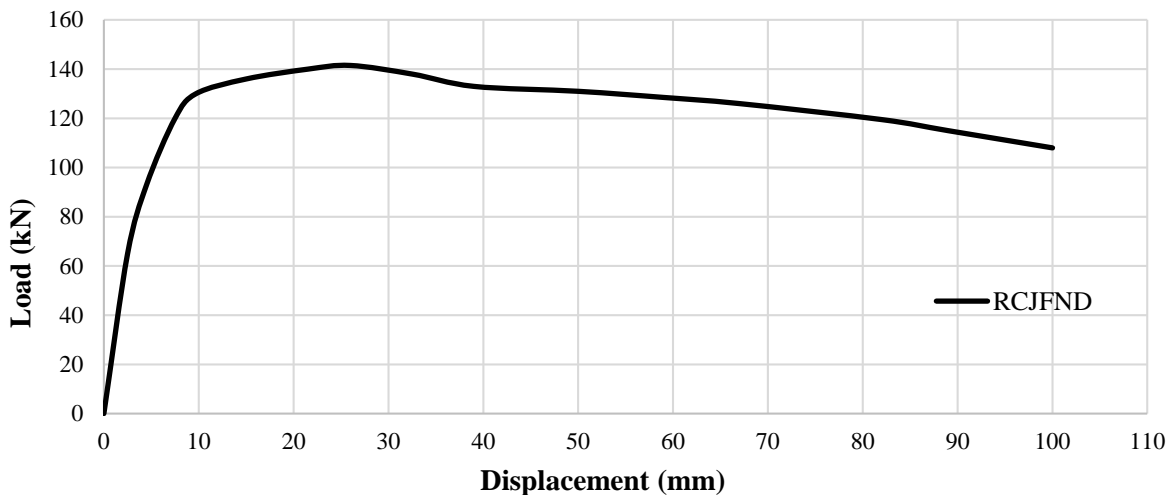
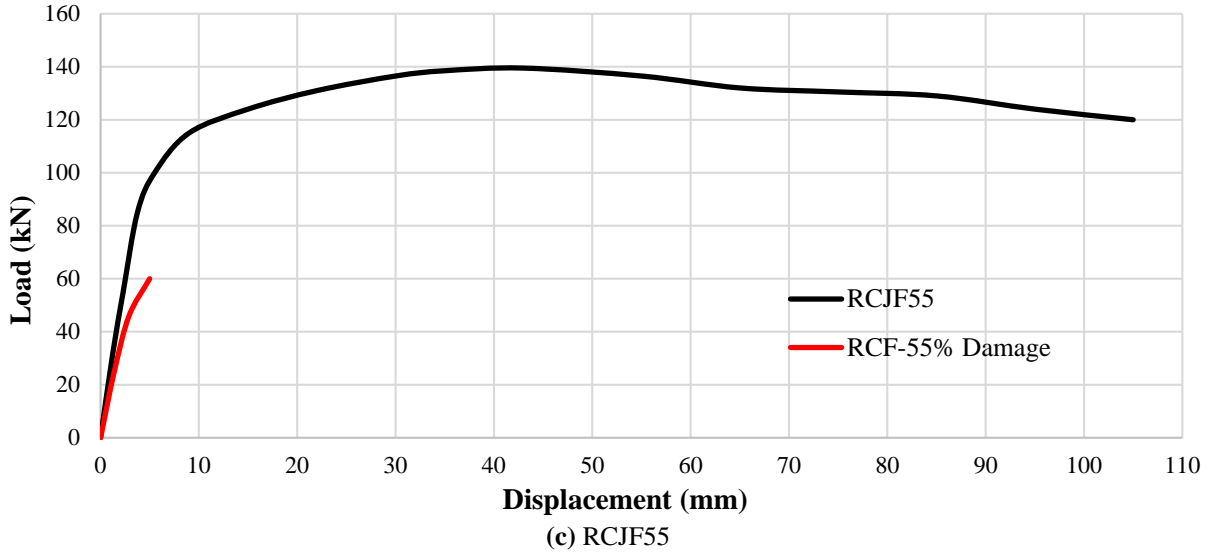
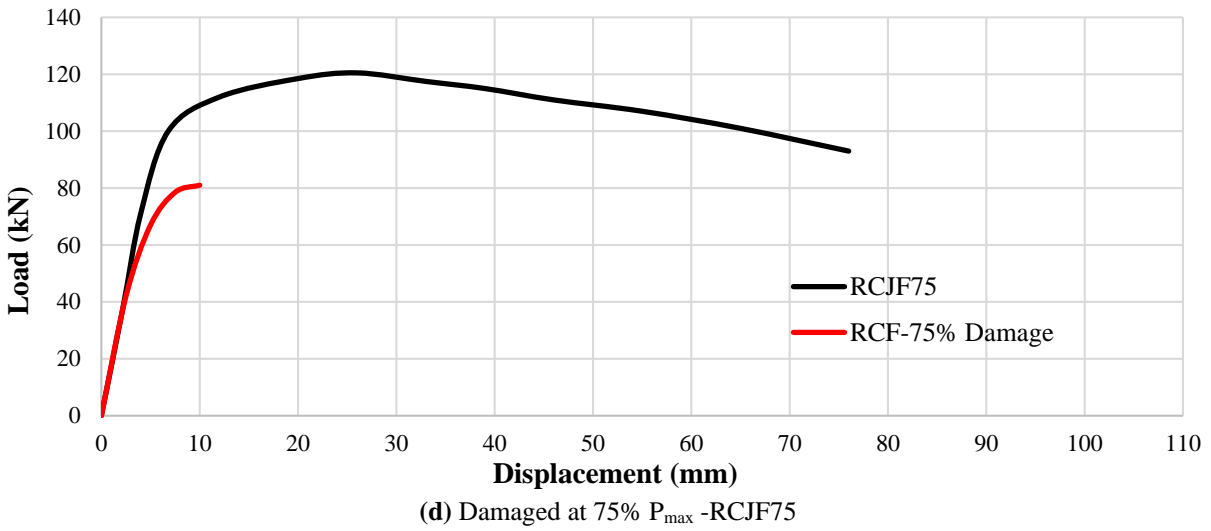
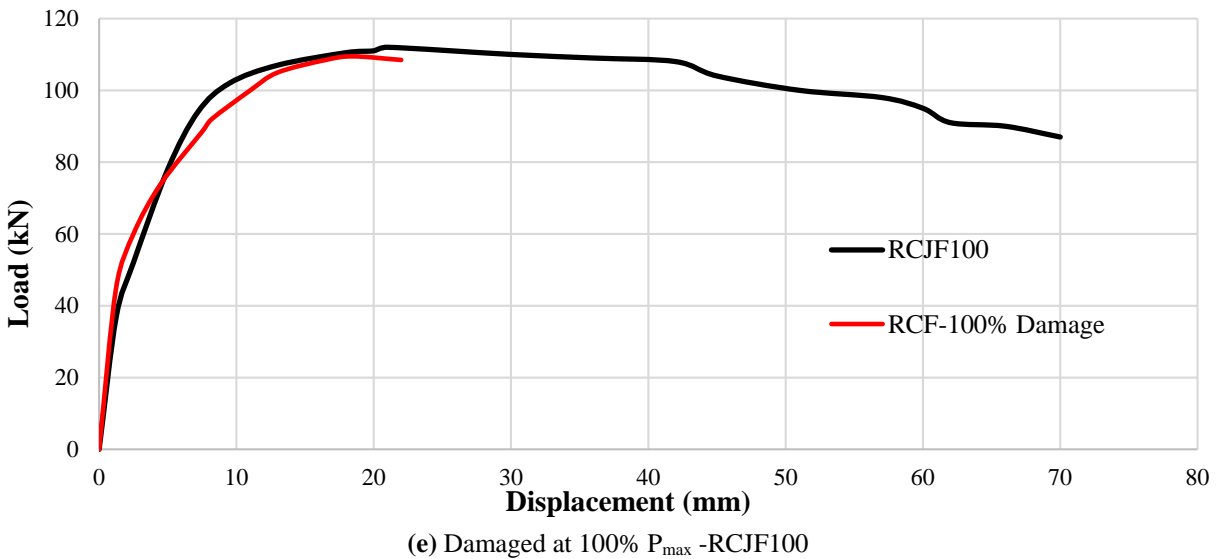
Fig. 5. Load-displacement curves of specimens

The load-displacement curves of five tested specimens are illustrated in Figure 5 with given details in Table 5. Also Figure 6 gives the comparison of all tested specimens curves. Tables 6 and 7 present the details of

The displacements of the undamaged strengthened specimen at three cracking, yielding, and ultimate stages were 1.43, 1.05, and 1.45 times of that of reference. These ratios for damaged strengthened specimens varied from 1.15 to 2.26. The reason for this increase was using HPFRCC composite with higher tensile strength around the panel zone and increasing flexibility and ductility of specimens even for those specimens with initial cracks.

Loads of undamaged strengthened specimen at three cracking, yielding, and ultimate stages were 1.57, 1.49 and 1.30 times of that of reference. These ratios for damaged strengthened specimens varied from 1.02 to 1.33.

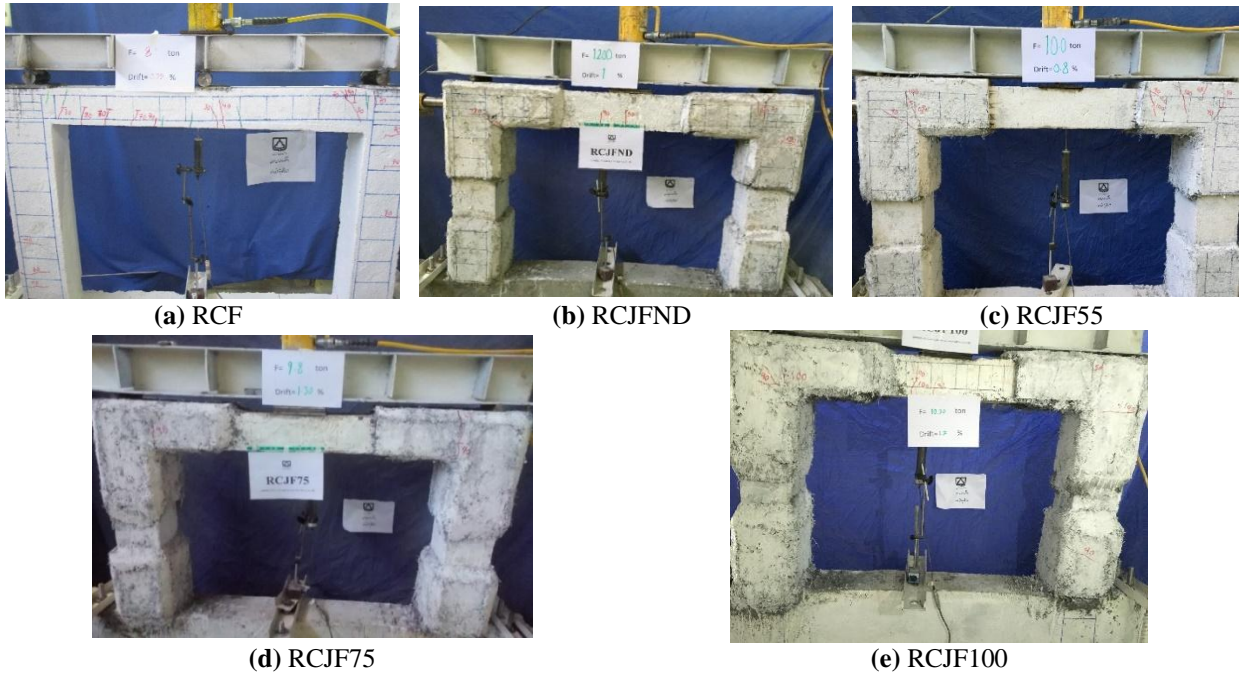
Fig. 8. Crack patterns yielding displacement

The crack patterns of five frames for two

different load stages, the yielding and maximum, are and shown in Figures 8 and 9. Up to yielding stage, all cracks for all specimens were flexural cracks at two ends of the beam and after that, the crack widths were extended at the beam and new cracks happened at two ends of the columns.
