Experimental Strengthening of Damaged and Un-Damaged RC Frames with Ultra-FRC Composite Layers

ABSTRACT: FRC concretes with high strength are practical material for strengthening existing particularly damaged concrete structures and able to dissipate seismic energy. The main purpose of this paper was to using high strength-FRC concrete for strengthening the damaged and undamaged frames. The five experimental specimens were loaded laterally and vertical gravity loads, simultaneously. The first specimen was a reference without strengthening, but the second same specimen was strengthened. The other three specimens were initially were loaded up to 55, 75, and 100% of the maximum capacity of the reference specimen and prepared as damaged specimens. The damaged specimens were laterally and vertically loaded. The test results showed that ductility of the undamaged strengthened frame was 2.2 times that of the reference specimen, while these amounts for three strengthened specimens (55, 75, and 100%) were up to 110, 60, 15 increase compared to the reference. The maximum lateral capacity of second undamaged, third fourth, and fifth damaged specimens were 38 and 35, 16, 9% more than that of

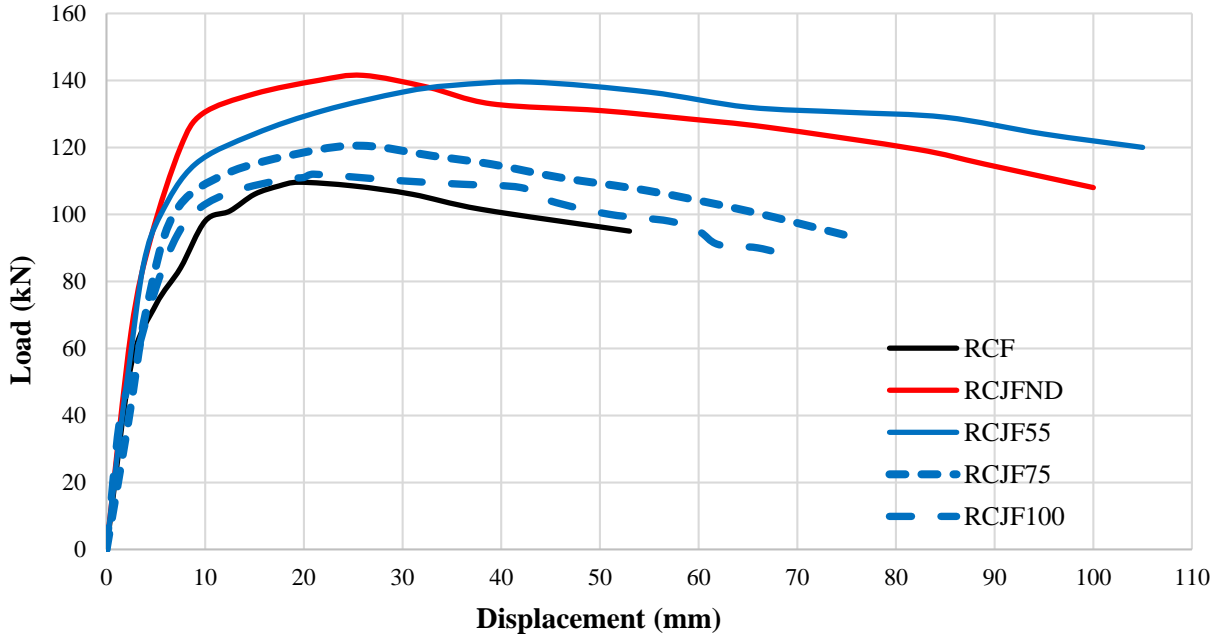
Fig. 6. Comparison of load-displacement curves

The load-displacement curves of five tested specimens are illustrated in Figure 5 with given details in Table 5. Also Figure 6 gives the comparison of all tested specimens curves. Tables 6 and 7 present the details of

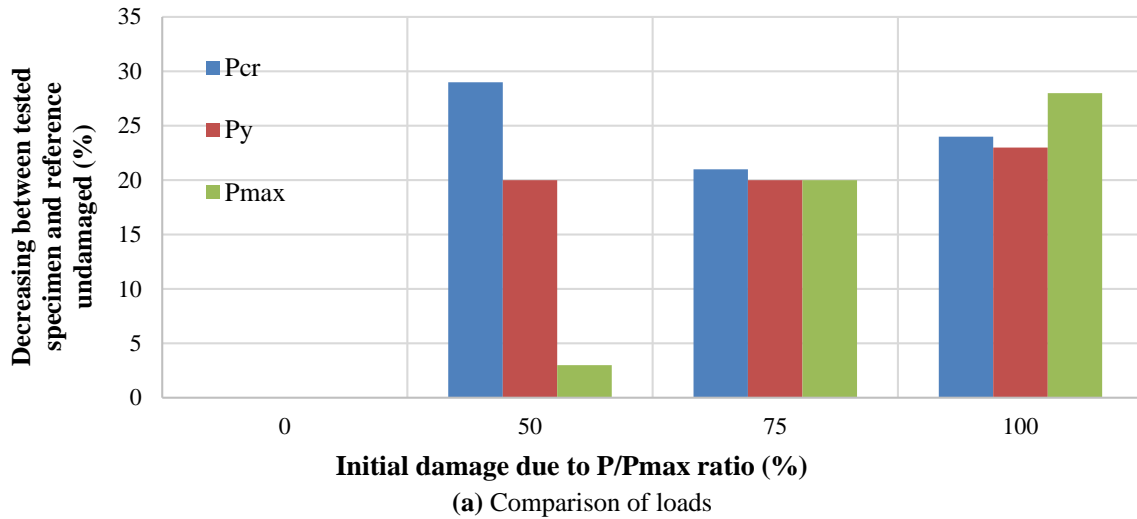
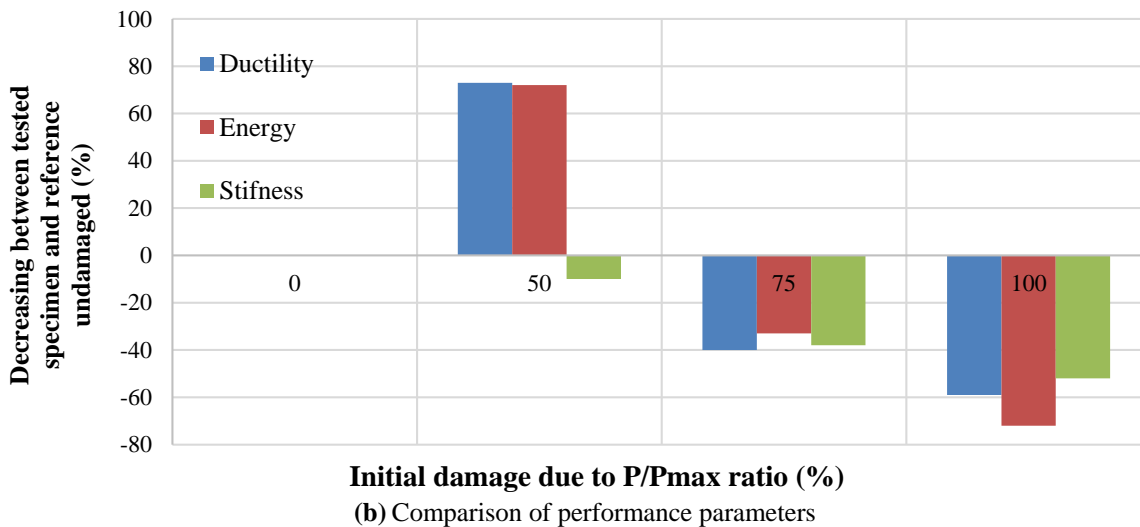
Fig. 7. Loads and performance parameter difference versus the percentage of damage of frames

21 and 22% compared to undamaged specimen, while these decreasing amounts for yielding loads were 21, 20 and 20%, respectively. More decreases were observed at maximum load capacity from 4 to 26% by increasing the number of initial cracks. The significant decreasing happened for stiffness amounts of damaged frames from; 12, 38 and 51% for specimens with of initial damages of 55, 75 and 100%.

The minor damage 55% (less than yielding stage) had a positive effect on ductility and energy absorption of the frame and these amounts were increased up to 73%. The ductility and energy absorption of frames with 75% (almost at the yielding point) and 100% (maximum damage) were averagely decreased up to 37 and 67%. The differences in loads and performance parameters of all five frames versus the percentage of damage of frames and the effects of the proposed strengthening method are shown in Figure 7.

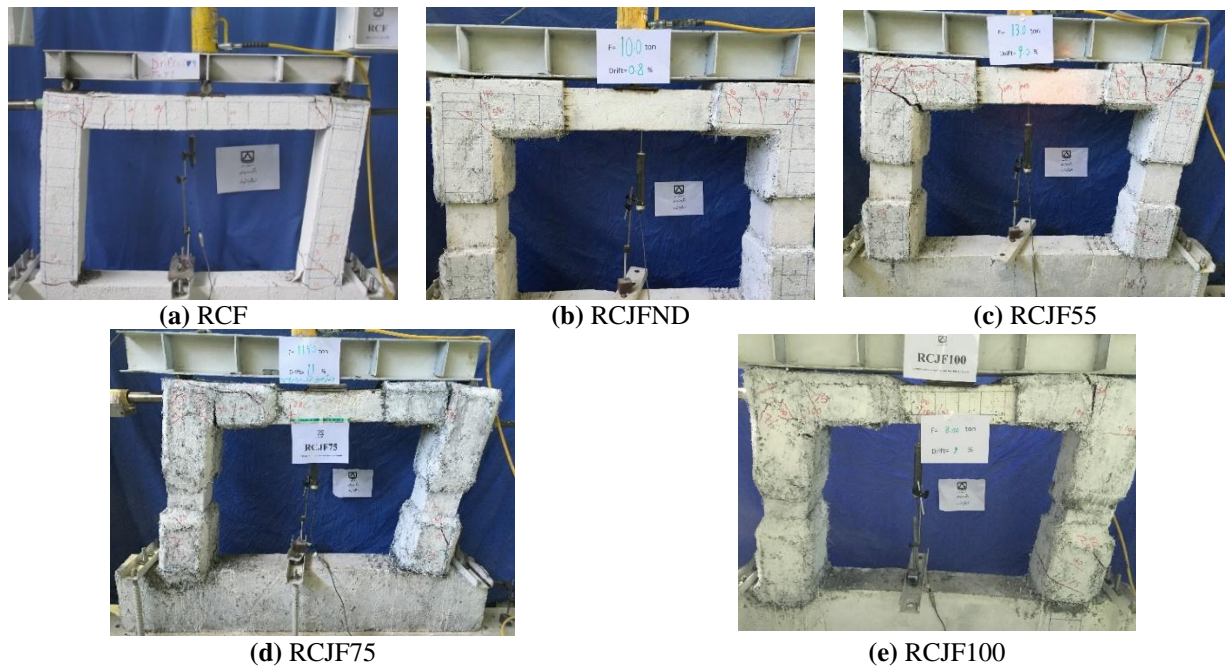
Fig. 9. Crack patterns ultimate displacement

The crack patterns of five frames for two

different load stages, the yielding and maximum, are and shown in Figures 8 and 9. Up to yielding stage, all cracks for all specimens were flexural cracks at two ends of the beam and after that, the crack widths were extended at the beam and new cracks happened at two ends of the columns.
