Assessment of Corrosion in Offshore R.C. Piers and Use of Microsilica to Reduce Corrosion Induced Oxidation (A Case Study of Wharves 11 and 12 in Imam Khomeini Port, Iran)

2. Location of Case Study Offshore

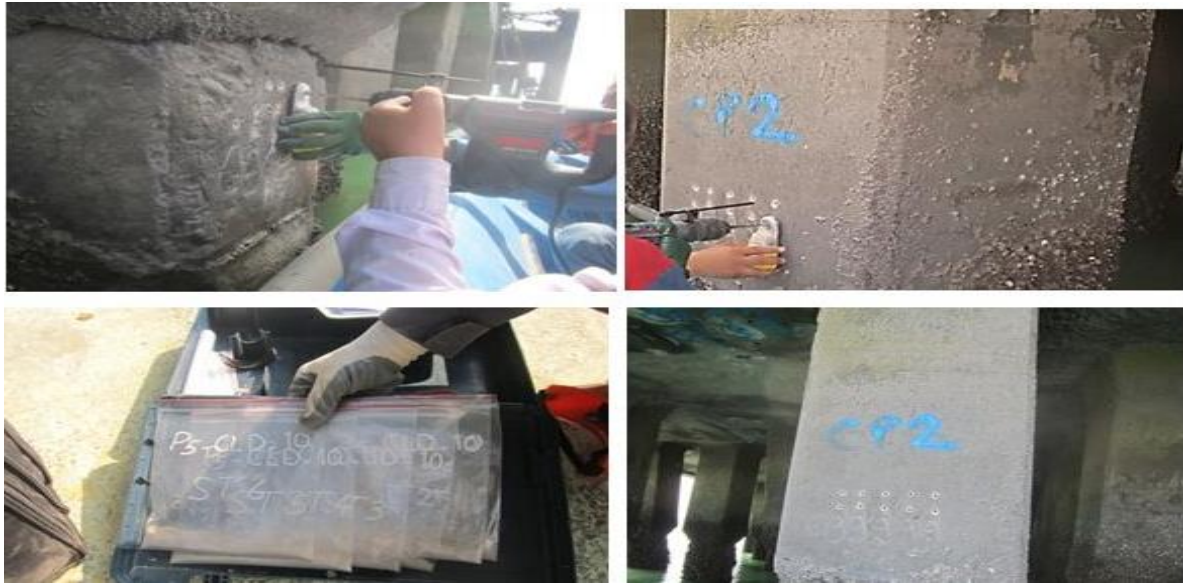
Fig. 3. Concrete drilling to get concrete powder

dug. The resulting concrete powder was stored and encoded bags to prevent any moisture. As for the core extraction method, first the sample of the cylinder was taken from the concrete held by a clamp. Then, the powder was prepared from the primary surface layer of each member by drilling a hole on the basis of the process described above. Finally, the samples were transferred to the laboratory, where steps were taken to prepare the solution by passing the powder through a 70-point sieve. It should be noted that an on-site drilling method was used at the pier (Figure 3).

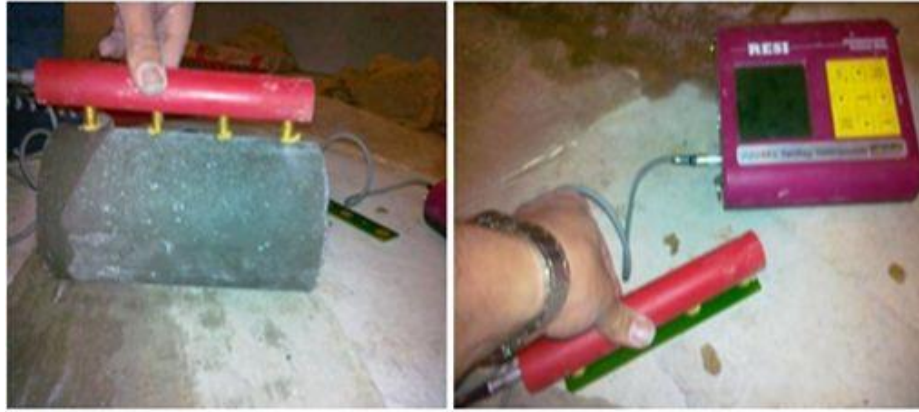
Fig. 5. Measuring device electrical resistivity

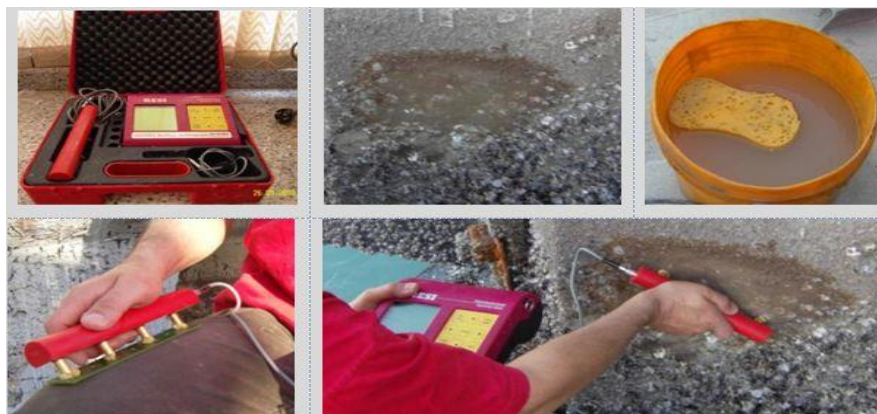
Fig. 6. A view of the concrete superficial electrical resistivity test performed by using the Wenner method on the concrete pier

A concrete electrical resistivity test was performed at 23 points on the concrete Piers 11 and 12. The results are shown in Table 2. An outline of the results obtained by summarizing an electrical resistivity test for different elements of structure is shown in Table 3.

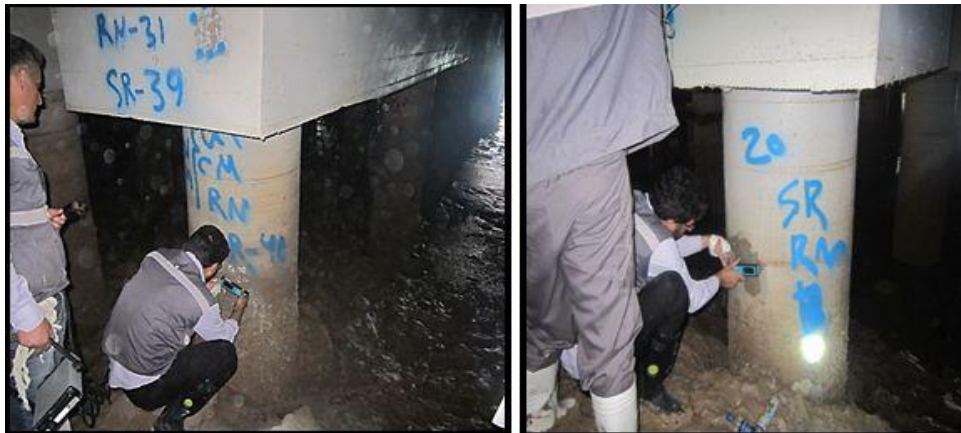
Fig. 7. Concrete electrical resistivity test on Piles docks 11 and 12

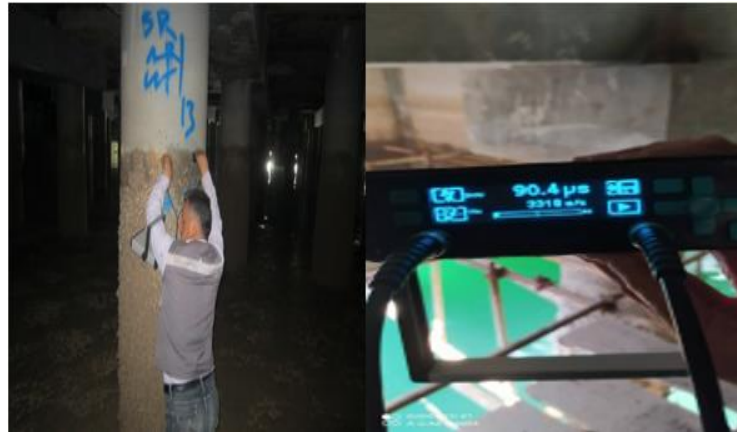
Fig. 8. Concrete ultrasonic test on piles, slabs and forehead at Piers 11th and 12th

A concrete ultrasonic test was performed by using a Pundit Lap + device on different members of the structures at Piers 11 and 12. This experiment was performed to determine shear wave velocity in concrete, and to determine concrete mechanical elasticity modulus. Here, a concrete ultrasonic test was performed at 15 points of Piers 11 and 12. The results are shown in Figure 8 and Table 4.

A concrete qualitative classification using pulse velocity is shown in Table 5 (Maierhofer, 2010). The average quality of concrete in the beams is as follows: poor in piles, deck slabs, and pier forehead. The results of the concrete shear wave velocity test in different structure members are summarized in Table 6.

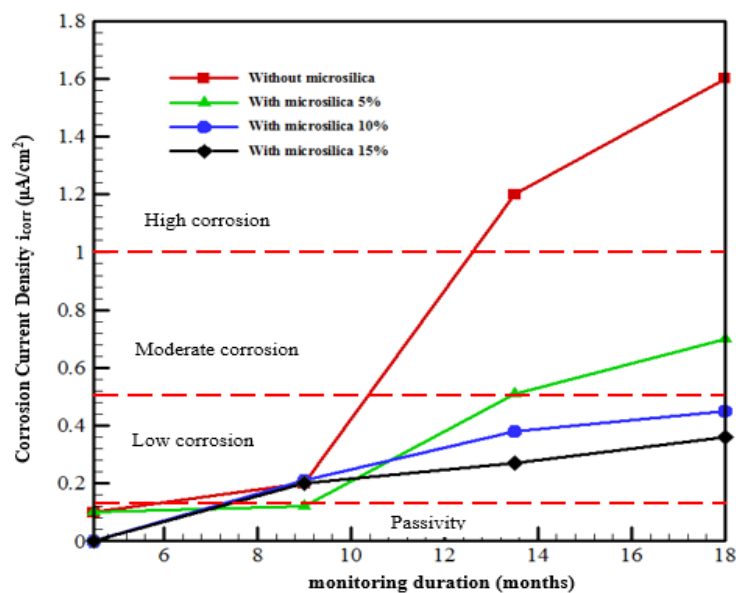
Fig. 10. Corrosion rate of concrete specimens at different times (SP = 0.6, w/c = 0.34)

The results are shown in Figures 10-12. In Figure 10, the effect of microsilica on the compressive strength of concrete for 28 days, with three water-to-cement ratios and 3% superplasticizer are shown. It can be seen from the figure that the average compressive strength increases by 30%, compared with the control specimen without microsilica, thus reducing the ratio of water to cement, as well as the use of microsilica. In these figures, the corrosion current density is presented, in terms of the age of concrete (i.e., corrosion duration), for specimens containing microsilica 15%, 10%, and 5% (weight of cement), and for those without microsilica. This involves Type 2 cement. After 18 months, the corrosion current density within the range of 5%, 10%, and 15% was less than that of the specimen without microsilica (see Figures 11 and 12). The fineness of the microsilica grains, compared with the round grains of cement, can be said to be the reason for this decrease. First, they fill very fine spaces of glaze when they are placed next to the cement glaze. Secondly, they combine with calcium hydroxide $[(OH)_2]$ resulting from the dewatering of the cement and convert it into hydrated calcium silicate because they are chemically active. In this way, voids are reduced in the cement glaze, the calcium hydroxide changes into a more solid body (similar to other cement paste

silicates), the cement paste texture becomes more uniform, and the concrete properties are improved. In all three figures, the corrosion current density is shown on the basis of the age of concrete with three water-to-cement ratios (0.34%, 40%, and 45%) and by considering 3 percentages of different microsilica. These figures show that the corrosion current density within the range of 10% and 15% is much lower than that of samples without microsilica and the instances of corrosion intensities are very close to each other. It can be observed that the difference between the corrosion current density of mixtures containing 10% microsilica, and that of mixtures containing 15% microsilica, arises from an increase in calcium hydroxide, which itself results from the hydration of cement and water in higher grade mixtures. As a result, when there are higher amounts of microsilica, they increase the gel and neutralize the negative effect of the excess mixture. Although the ratio of microsilica is 15% lower than the other two ratios of it, because of the trend of severe corrosion in shapes, it can be seen from these figures that the two ratios of microsilica (i.e., 10% and 15%) are very close to each other and the important factor at this stage is the economics of microsilica consumption, as indicated by its large volume in this project.

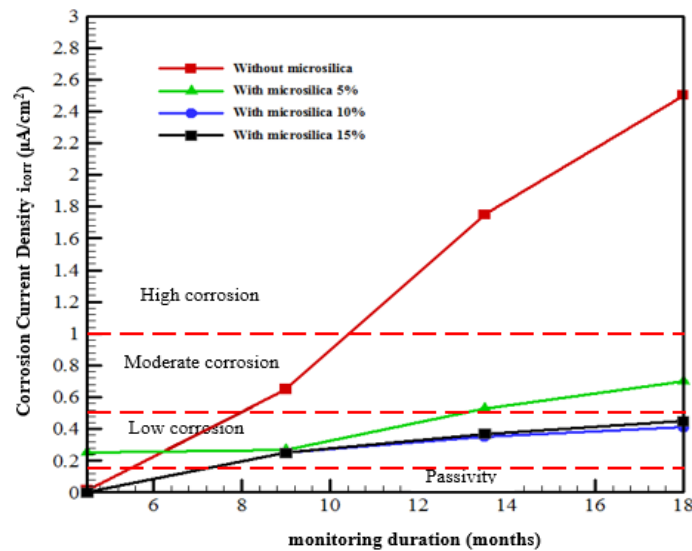
Fig. 12. Corrosion rate of concrete specimens at different times (SP = 0.2, w/c = 0.45)
