Structural Failure of Masonry Arch Bridges Subjected to Seismic Action

ABSTRACT: This study investigates the seismic response of a historical arch bridge using a macro-modelling technique in Finite Element (FE) software ABAQUS. A comprehensive investigation involving documentary sources and on-site assessments has facilitated a thorough understanding of the case study, the Halilviran bridge. 3D finite element models incorporating damage plasticity behavior were constructed for the FE model. The masonry units were modelled with the Concrete Damage Plasticity (CDP) material model, and the backfill was developed with the Mohr-Coulomb (M-C) material model. Nonlinear dynamic analysis was utilized to predict the progression of damage to the bridge and determinate the most susceptible structural components. The seismic performance of the case study was evaluated through an examination of the outcomes utilizing contour plots depicting tensile damage, maximum displacements, and energy calculated from the tensile damage. The findings indicate that the spandrel walls, which are interconnected with the pier, and the inner section of the arches represent the most vulnerable components of mason

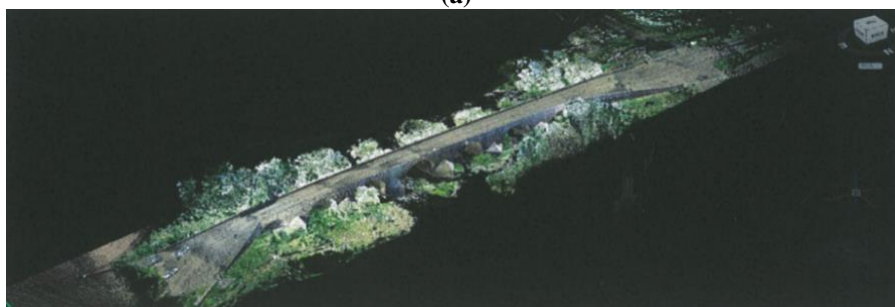
Fig. 1. Halilviran bridge: a) Location; b) 3D Scanning cloud image; and c) CAD drawing (Azar and Sari, 2023)

The seventh arch to the east has a special shape compared to the previous arches. It has a pointed shape that resembles the round arch, but is lower in height. Figures 1 and 2 show the architectural design, cross-sectional views and vertical views as well as the main geometric dimensions of the Halilviran bridge.

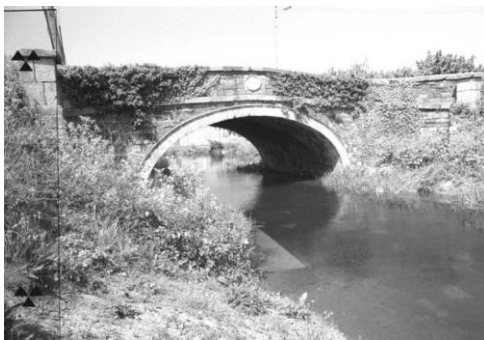
Fig. 7. Griffith bridge in Dublin, Ireland

limestone blocks with a joint thickness of around 1 cm. The examination and computational analysis of the Griffith bridge in Dublin, Ireland, are showcased in Figure 7. Figure 8 displays the finite element simulation of the deformation of the arch barrel and spandrel walls under the scenario where a fully loaded truck places its rear axle at the center of the span. Figure 9 exhibits the comparative data derived from numerical simulations and physical experiments conducted at the midpoint of the bridge's central axis during the passage of the fully loaded truck.

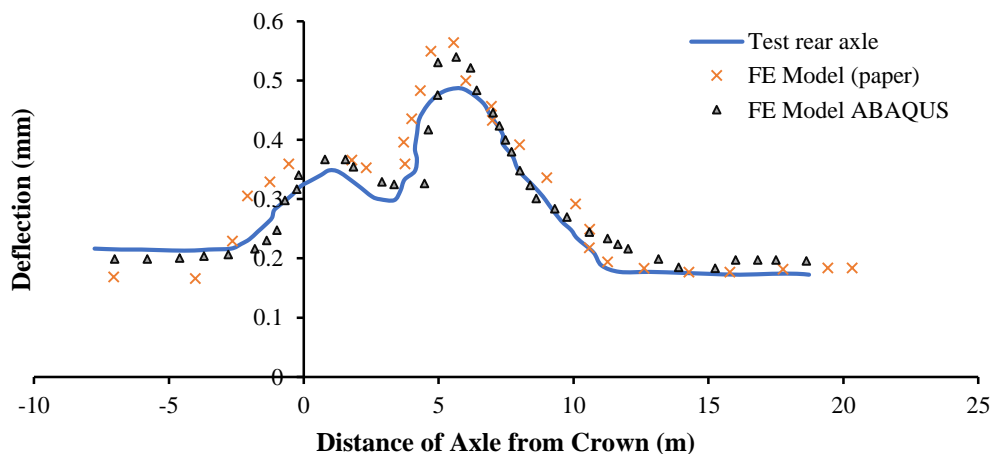
Fig. 9. Numerical and test crown displacements for fully loaded truck

The study indicated a maximum deflection of 0.43 mm in the experimental results, while the finite element model predicted a deflection of 0.54 mm.

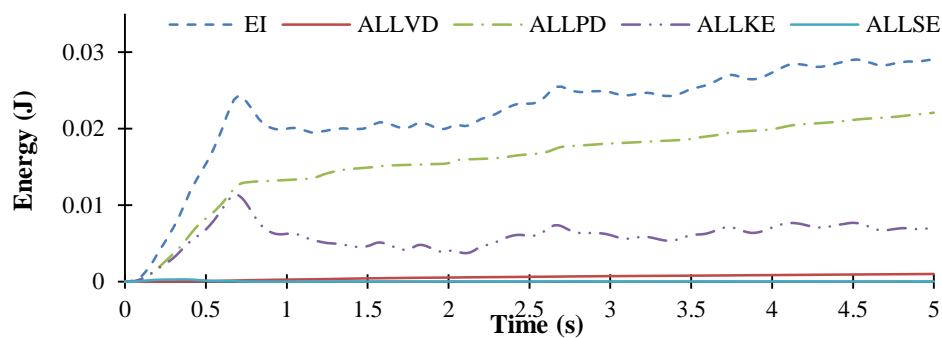
Fig. 12. Total input energy (EI), energy dissipated by viscous effects ($W\xi$), hysteretic energy (Wp), kinetic energy (Wk) and elastic-strain energy (W_e)

Figure 12 illustrates the variations over time in the energies (EI), ($W\xi$), (Wp), (Wk) and (W_e) within the model. The primary dissipation of input energy occurs due to plastic deformation. This phenomenon is attributed to the localized damage in a limited number of elements, thus validating the suitability of the selected CDP parameters. The study investigates the impact of tension and compression-induced damages on masonry materials, particularly in the context of seismic damage assessment for masonry

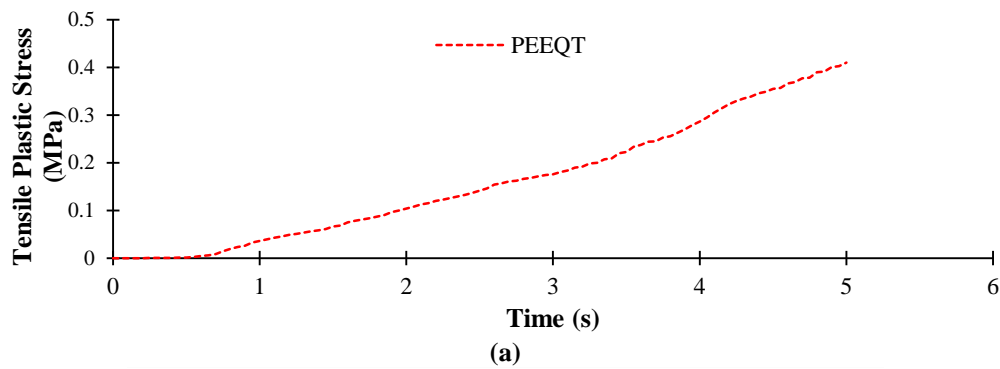
Fig. 13. a) Time histories; and b) Maximum principal (tension) strain contour maps of the arch

The study utilizes Figures 13 and 14 to present the maximum values and patterns of equivalent plastic tensile strains (PEEQT) in masonry arches and spandrel walls under the influence of longitudinal and transverse

strong ground motions. The distribution of equivalent plastic tensile strain (PEEQT) after 5 s of earthquake records reveals concentrated tensile plastic deformations around the bearing portion connecting the arches of the wall.

The masonry arches and spandrel walls exhibit peak plastic tensile strains of $4.7e^{-1}$ and $4.36e^{-1}$, respectively, with the strains predominantly localized in the lower interior sections of both structures. Additionally, the study highlights the maximum displacements of the bridge deck in the longitudinal and transverse

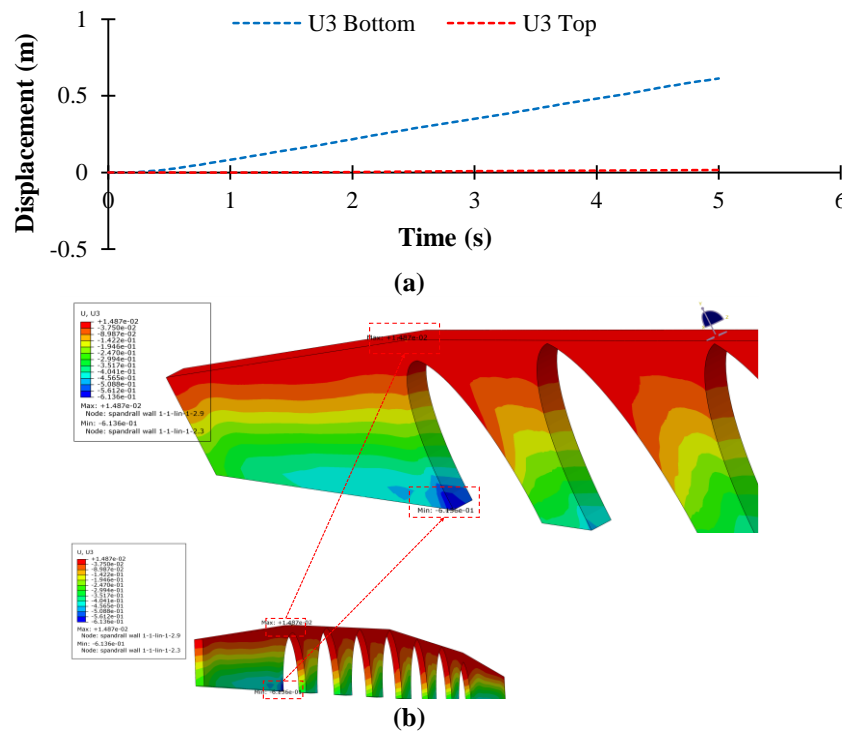
Fig. 16. a) Time histories of the spandrel wall; and b) Displacements in the transverse directions at the bottom contour maps

directions, as depicted in Figure 15. Figure 16 illustrates the dynamic displacements graphed in the horizontal directions at the upper and lower ends of the spandrel walls of the bridge. This graph illustrates the significance of the structural response in masonry bridges that takes place out of the plane.

The measurements are carried out to determine the horizontal displacements of the spandrel wall, leading to the manifestation of out of plane characteristics in the wall. The longitudinal displacements of the spandrel wall are assessed to establish its in-plane behavior. The stability of the spandrel walls and their relationship with

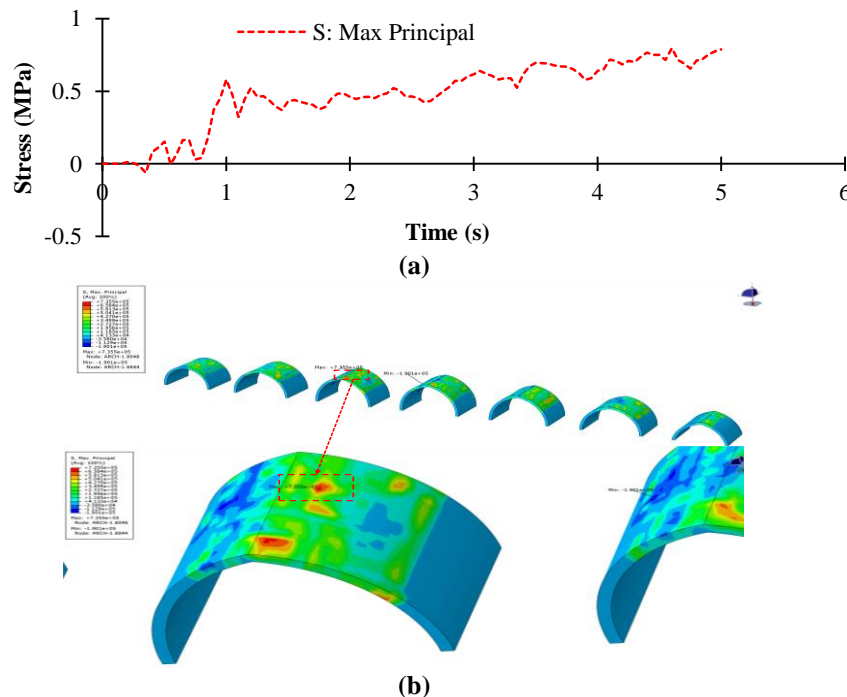
Fig. 17. a) Time histories; and b) Maximum principal (tension) stress contour maps of the arches

the arch barrel are crucial elements influencing the various challenges observed in masonry arch bridges. Figures 17-19 illustrate that the masonry unit undergoes peak principal stresses when exposed to intense ground motion along the arch interface.

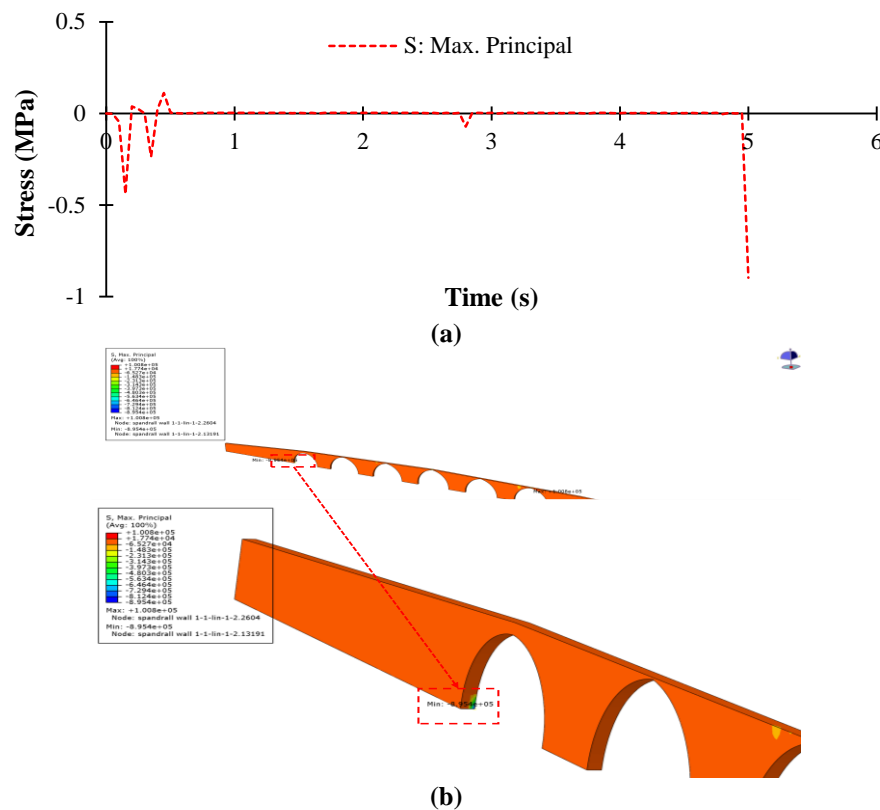
Fig. 18. a) Time histories; and b) Maximum principal (compression) stress contour maps of the spandrel wall

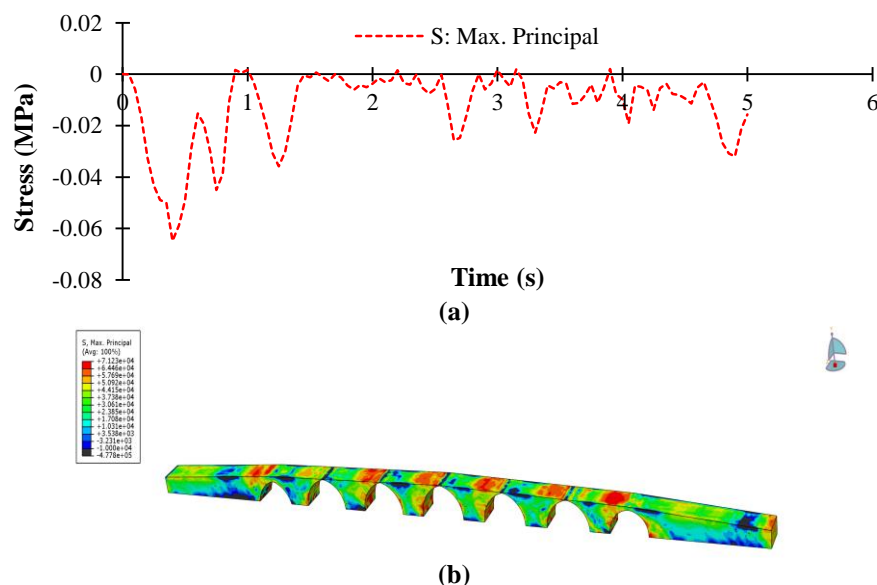
Fig. 19. a) Time histories; and b) Maximum principal (compression) stress contour maps of the infill

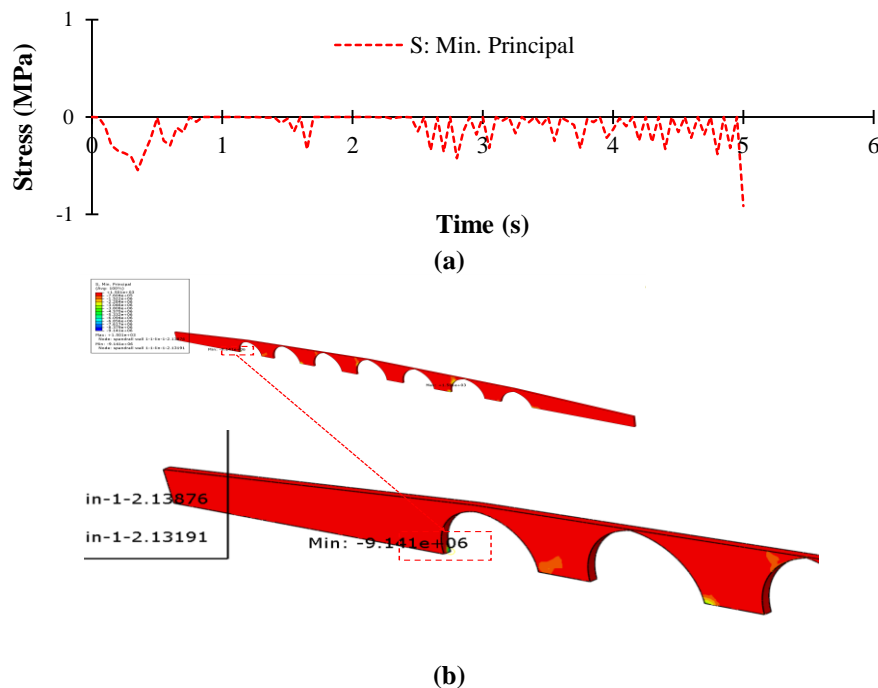
Fig. 21. a) Time histories; and b) Minimum principal (compression) stress contour maps of the spandrel wall

Figures 20 and 21 illustrate the changes over time in the minimum principal stresses and the specific stress regions. The minimum principal stresses determined in the analysis were below 3.15 MPa, which is

the upper limit for compressive stresses in masonry walls and vaults. However, the model showed increased stresses in certain segments of the bridge that approached the maximum allowable value.
